# Situation Photo Log

Wednesday, May 9, 2012

Kalamazoo River / Enbridge Spill

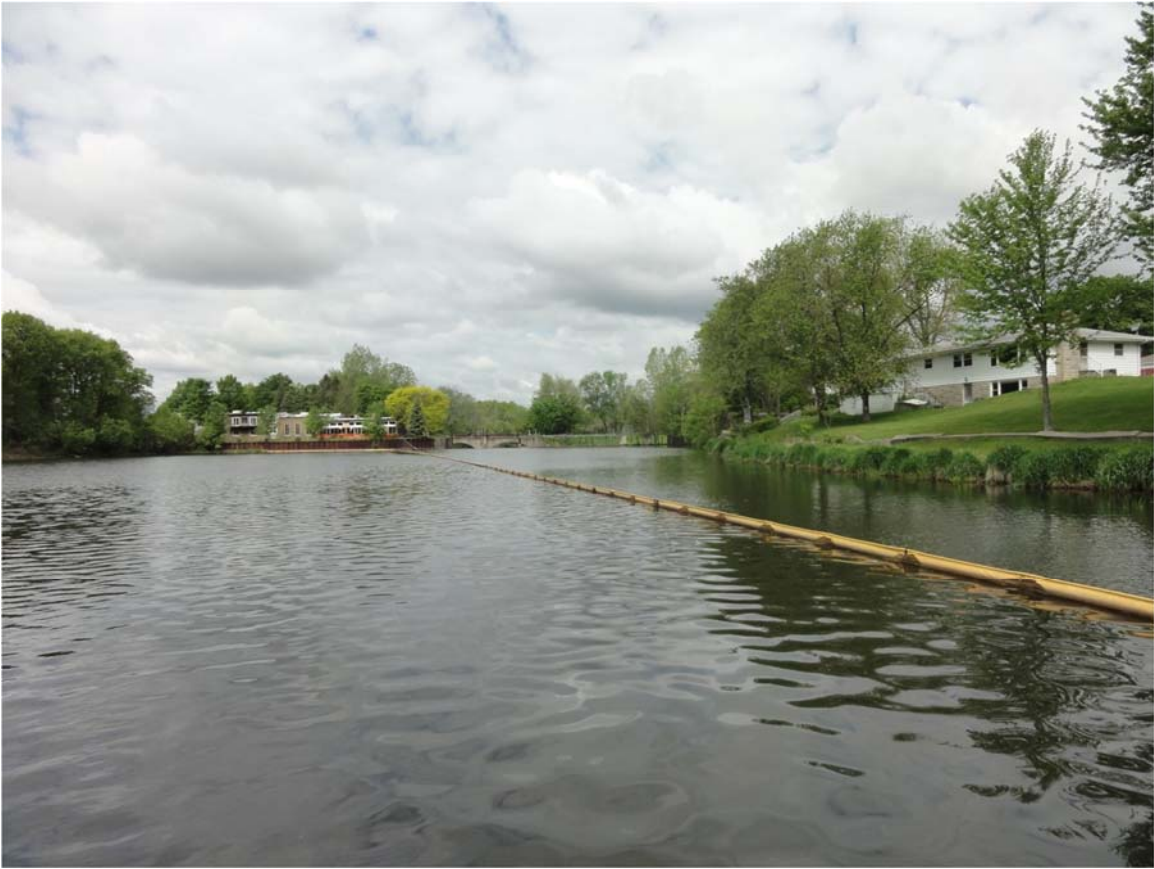
1. Ceresco Dam control point boom.

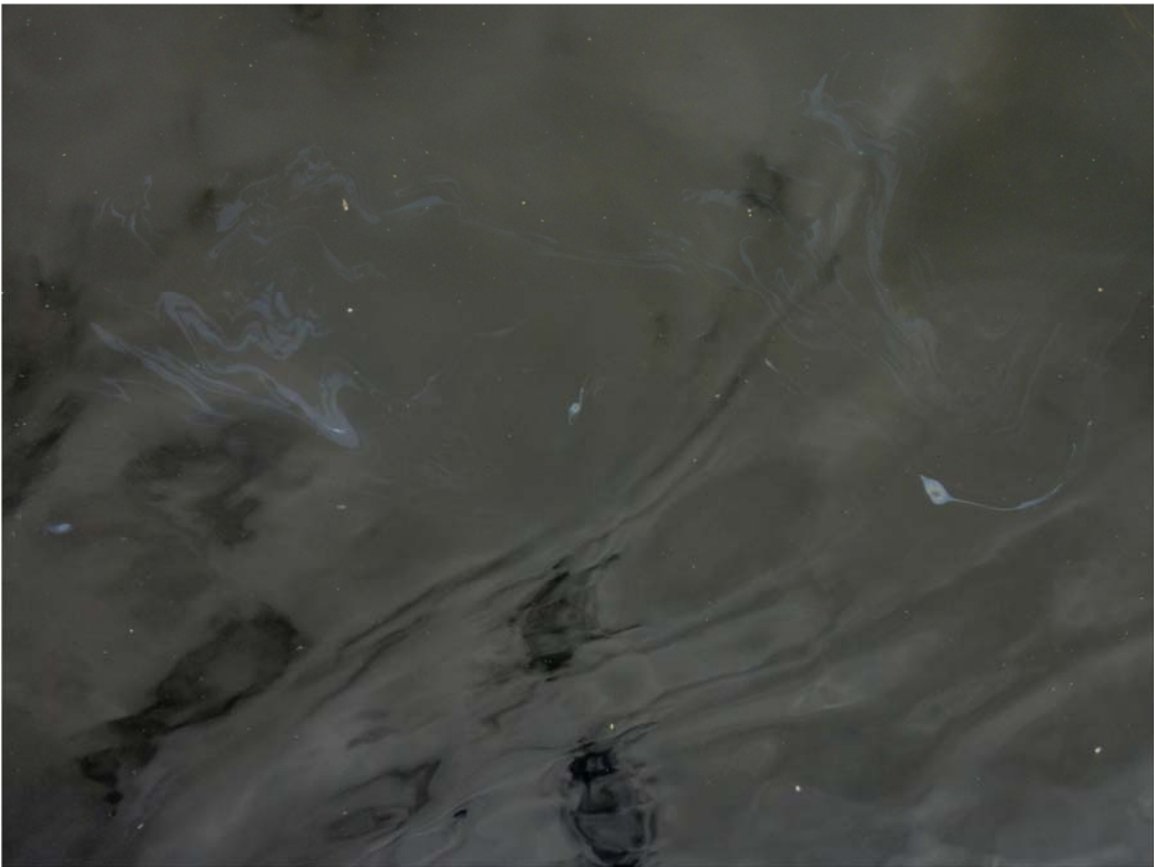
2. Sheen observed along Ceresco Dam's boom

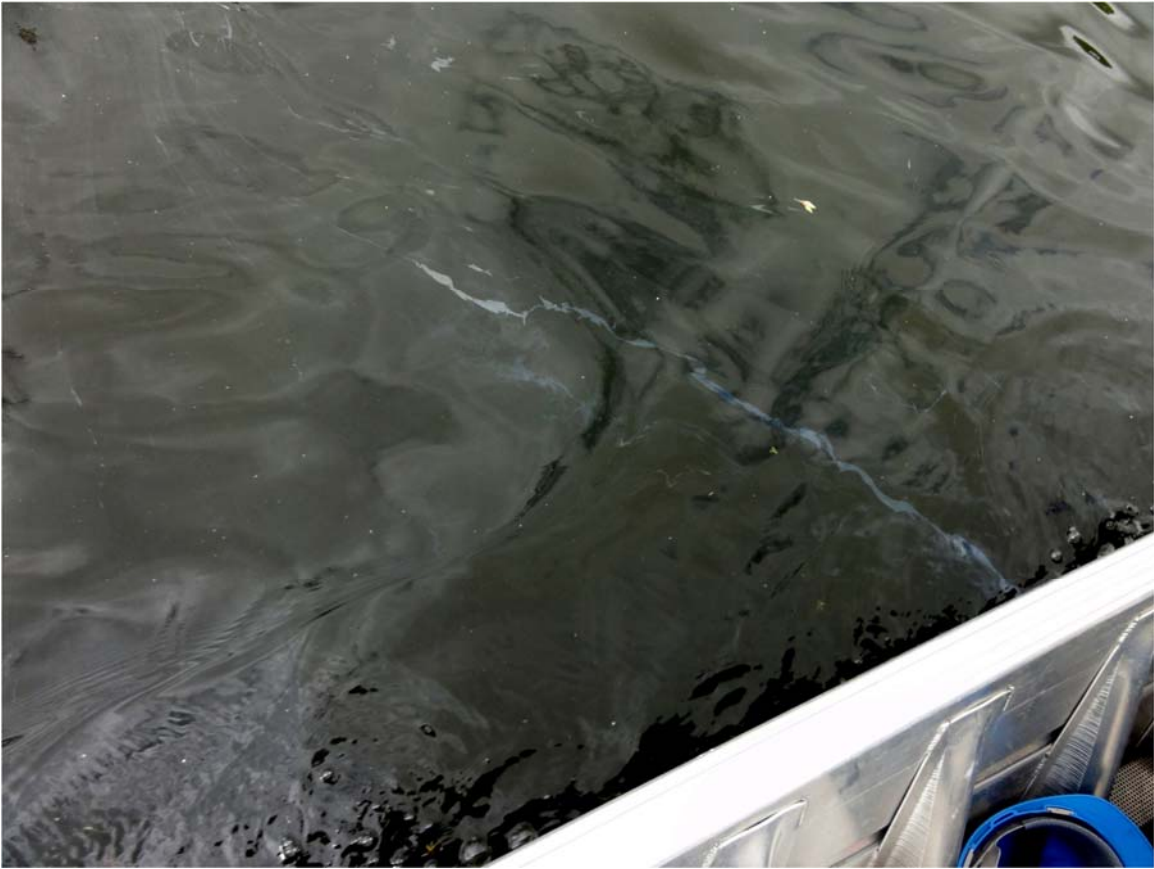
3. MP5.63 sheen observed. Sheen tests were performed here.

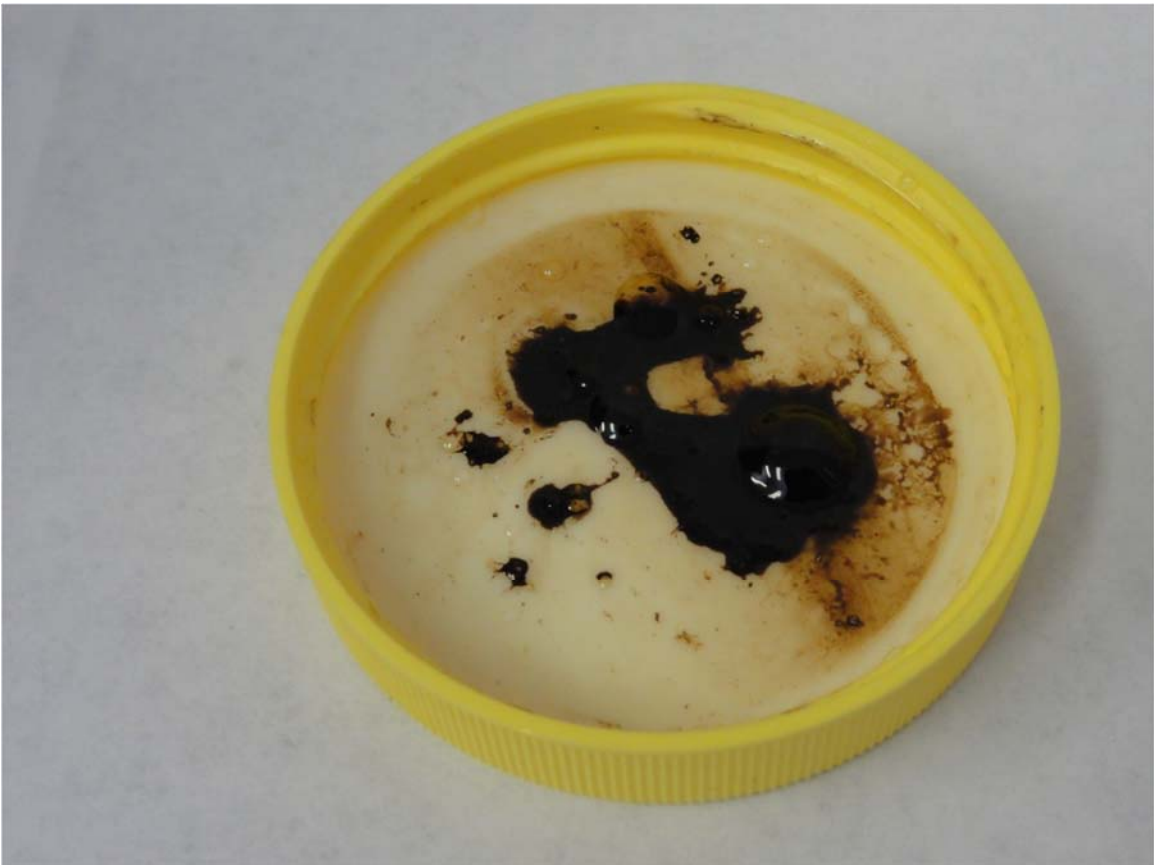
4. MP5.63 sheen observed. Jar test performed, oil stuck to jar lid.

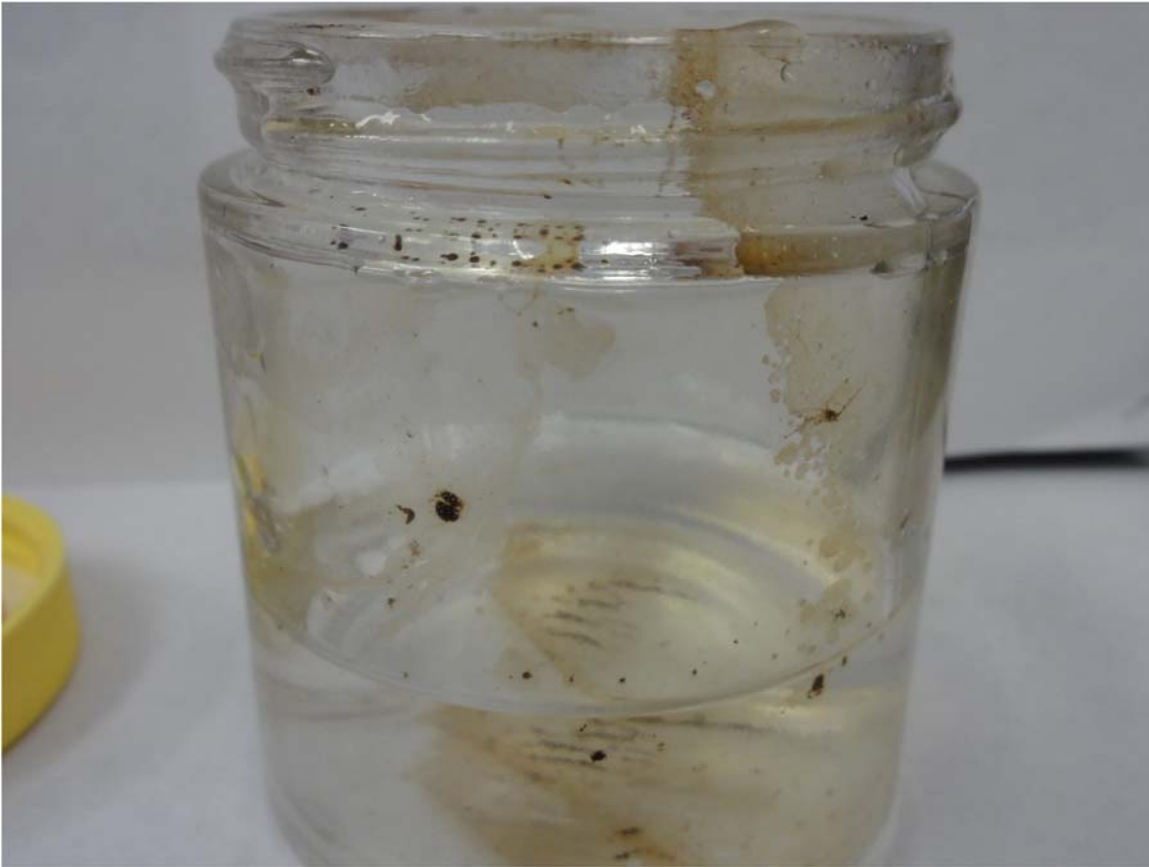
5. MP5.63 sheen observed. Jar test performed, oil stuck to jar.

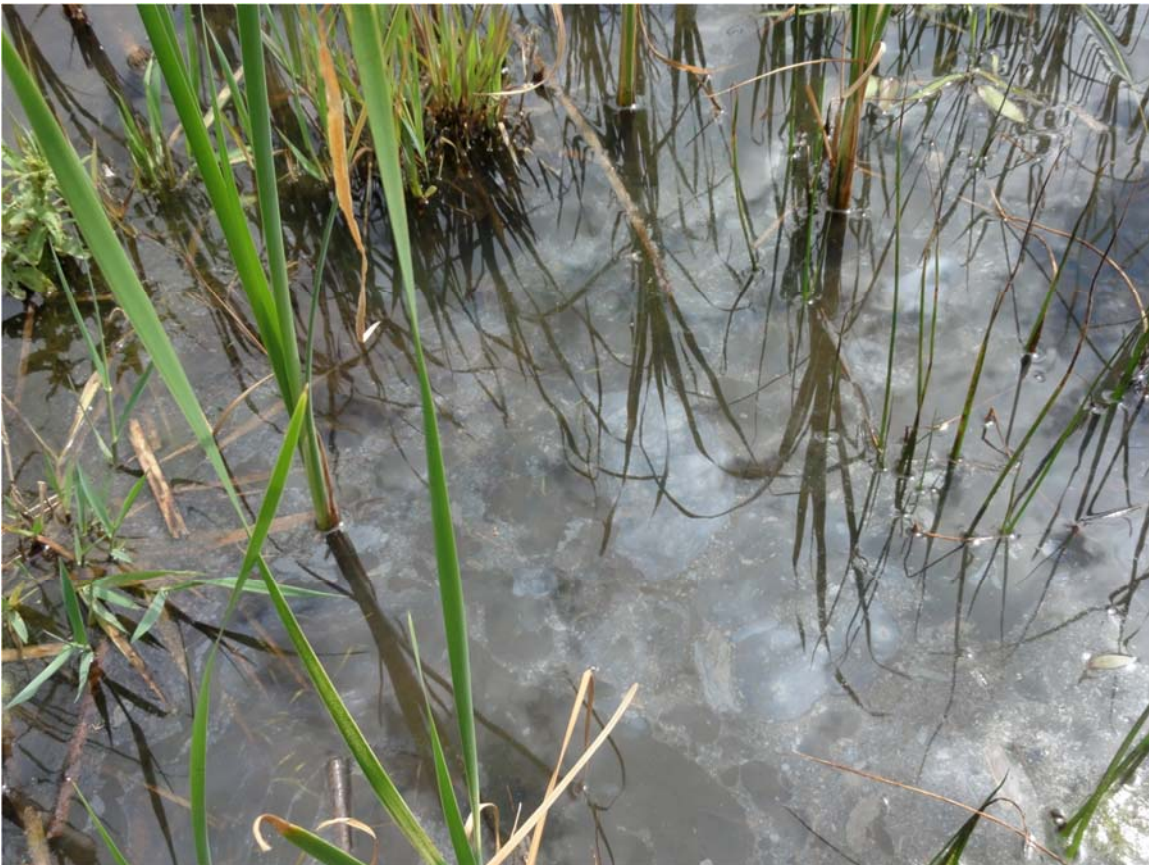
6. Island A pooled water sheen observed.

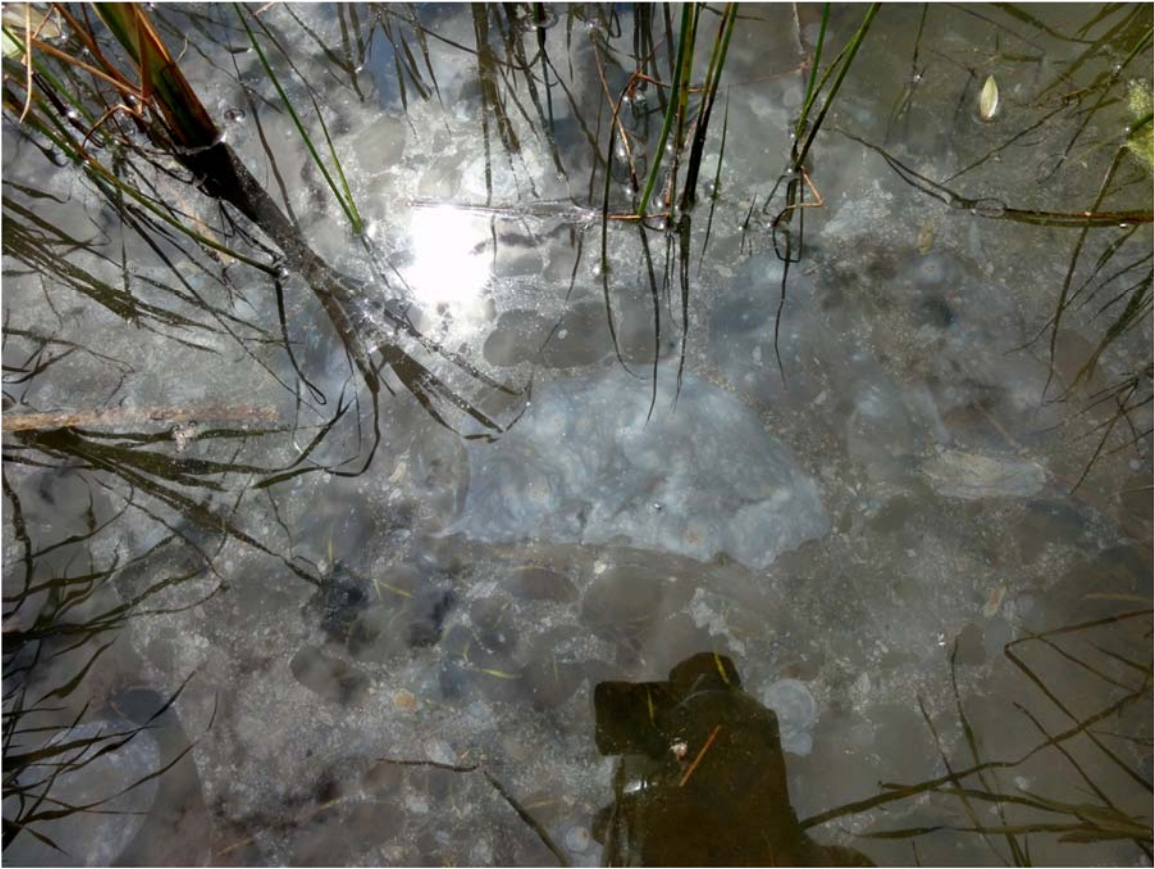
7. Island A sheen observed in pooled water.

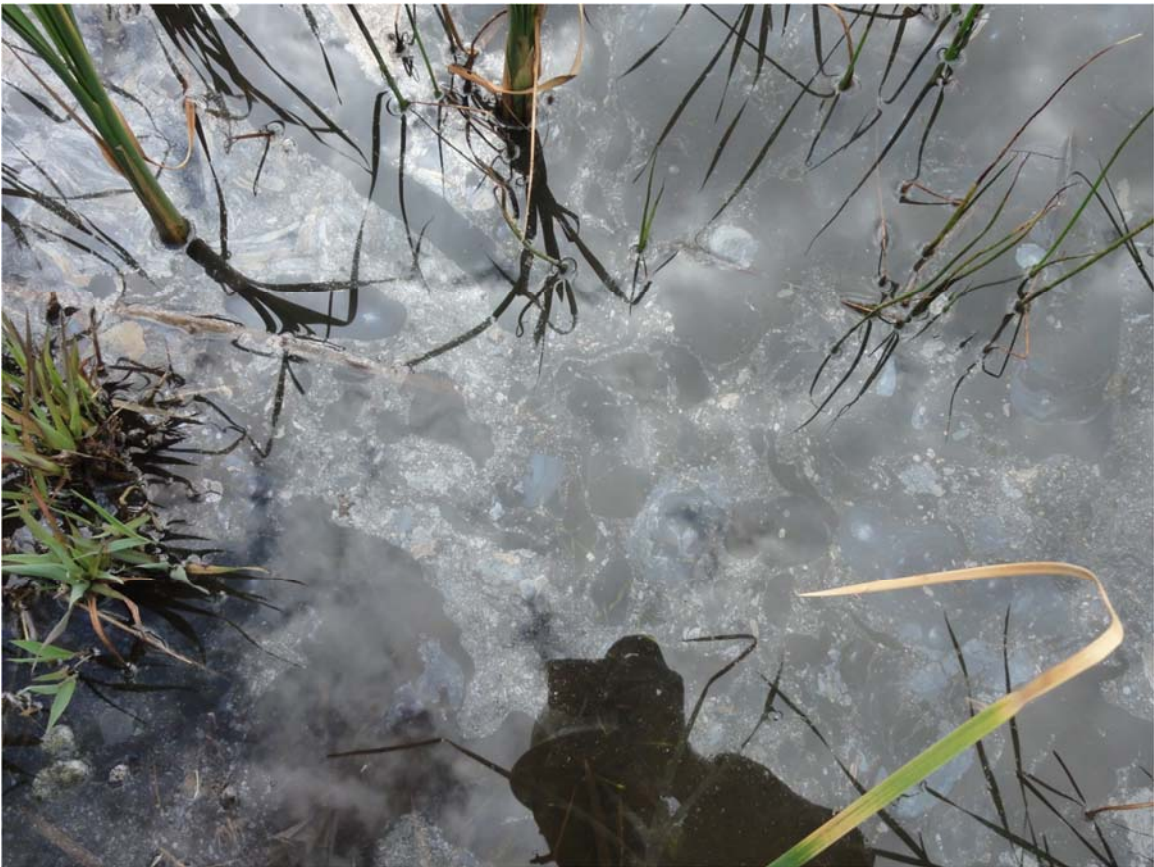
8. Island A pooled water sheen observed.

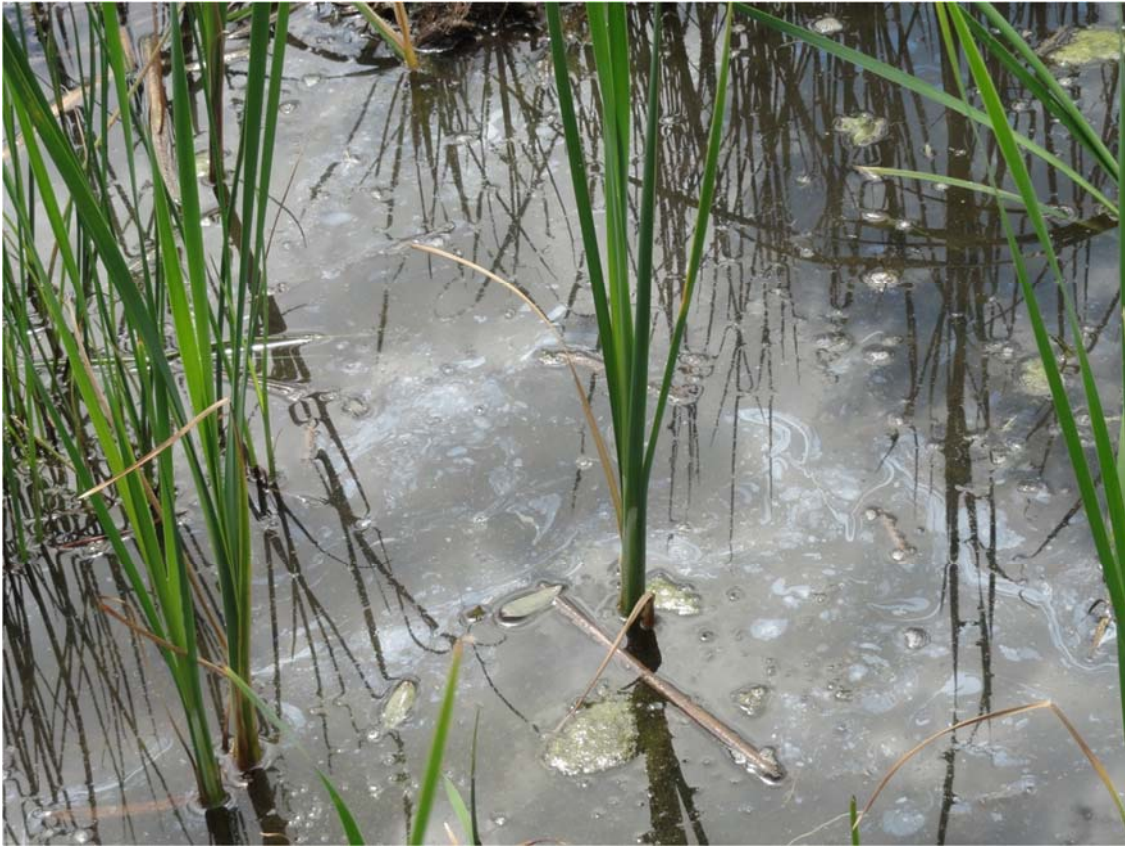
9. Island A pooled water sheen observed after walking through area.

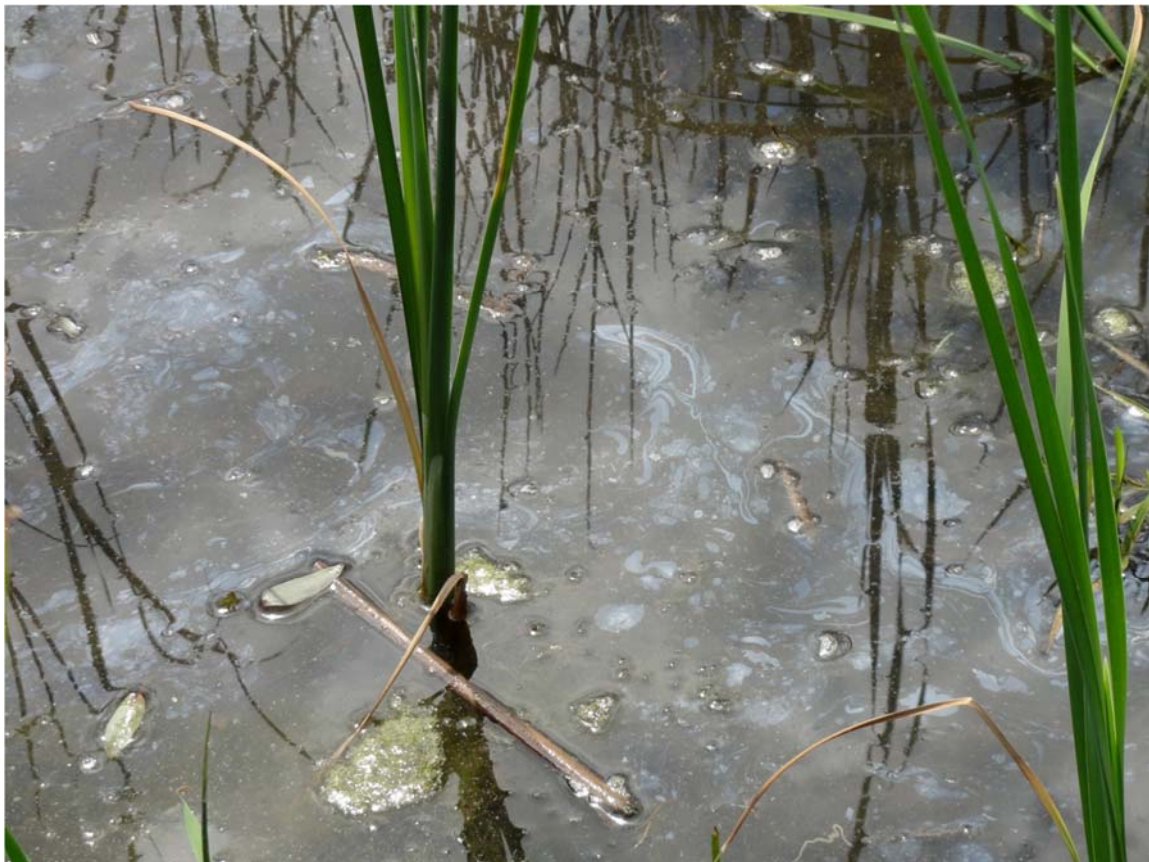
10. Island A pooled water sheen observed after walking through area.

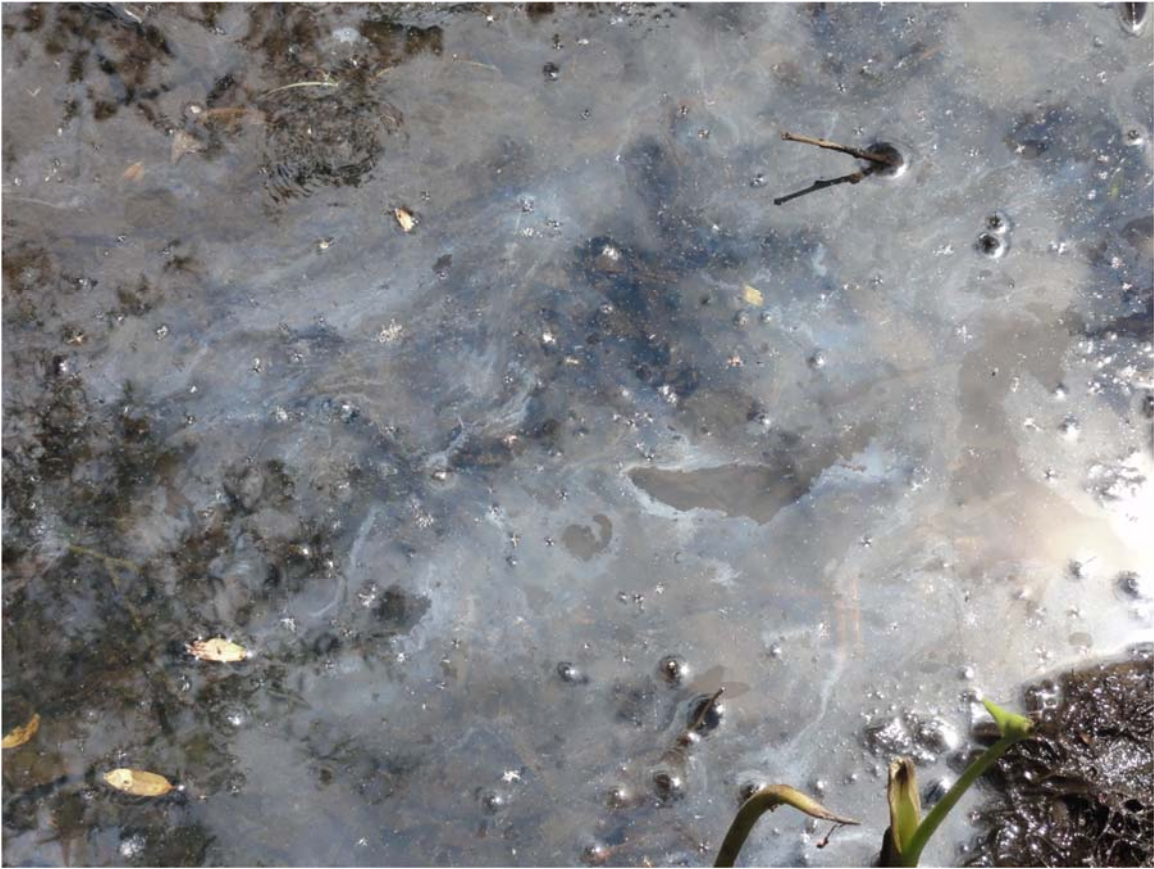
11. OB2.75 RDB sheen inspected and sheen tests performed.

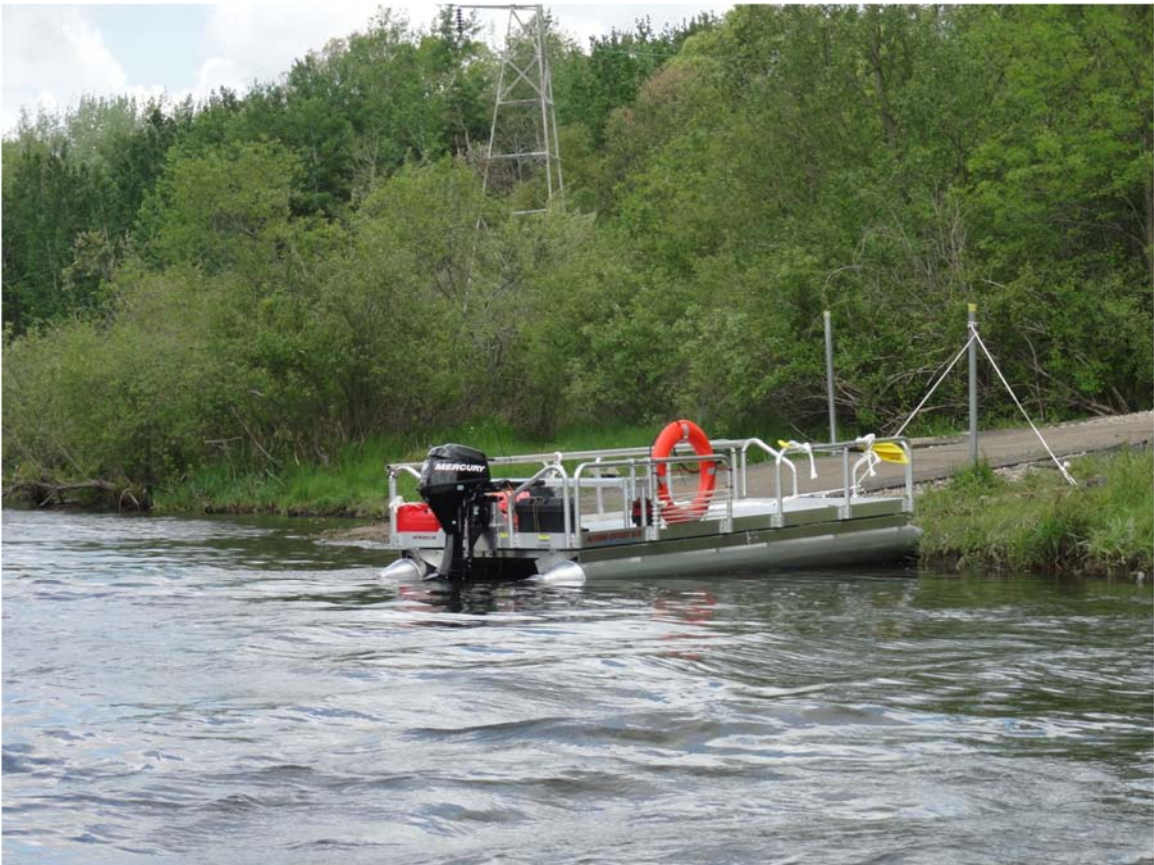
12. Sheen sweep pontoon boat deploying out of C0.4.

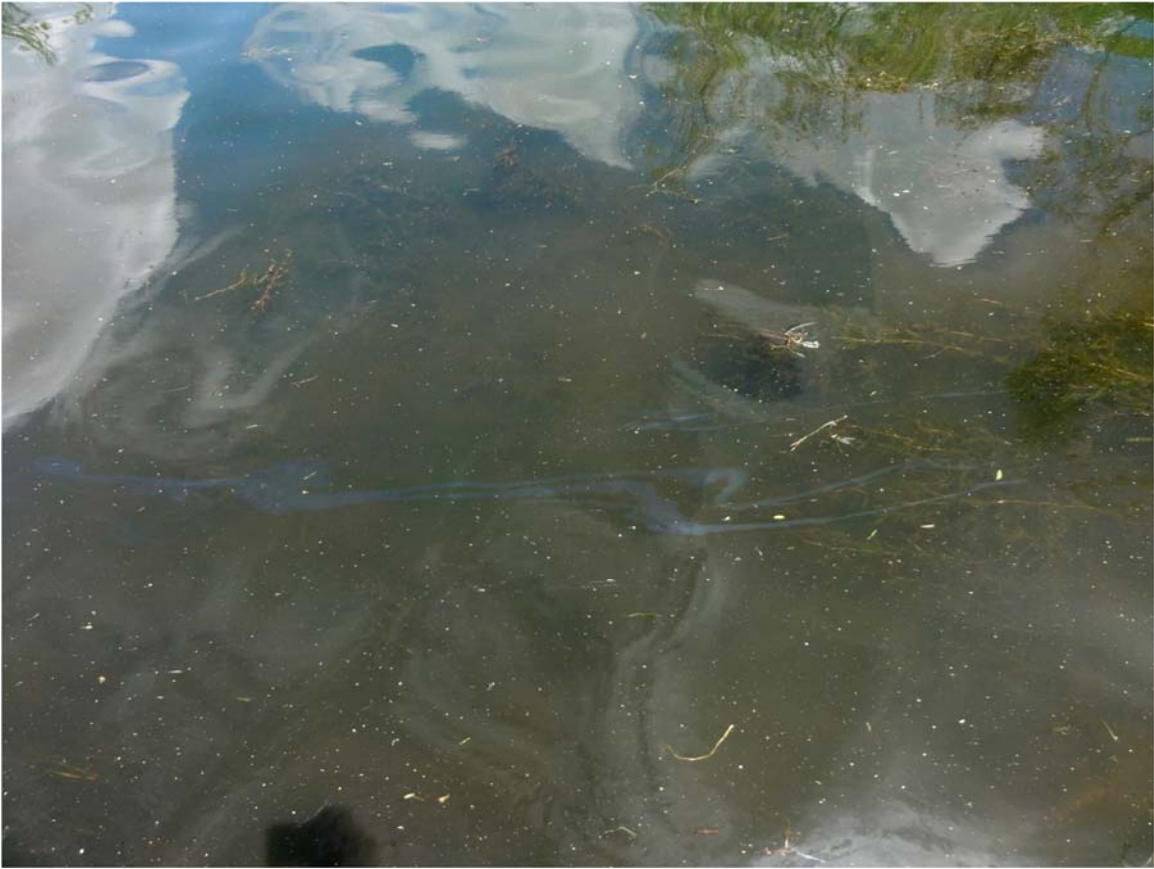
13. MP5.25 RDB sheen observed.

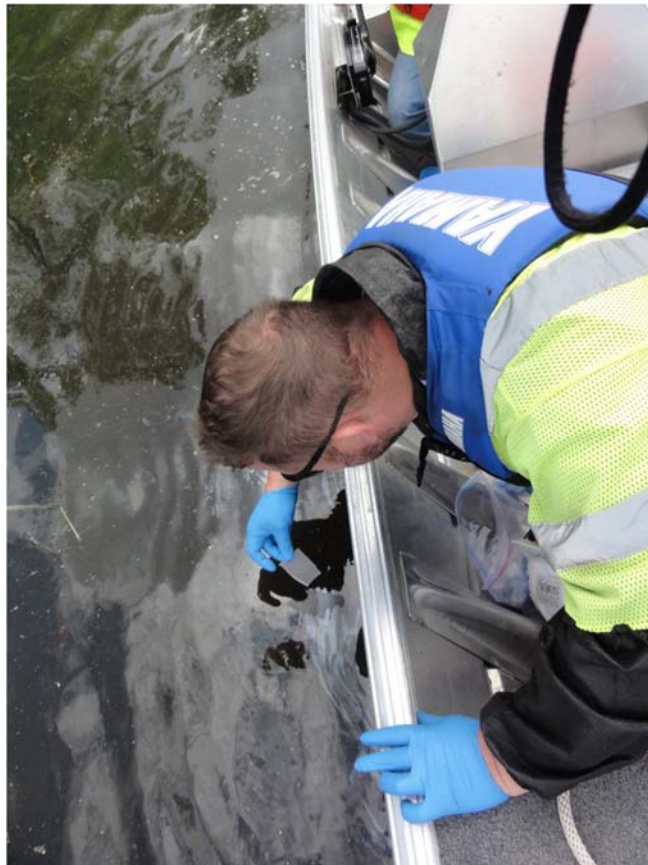
14. MP5.25 sheen collection.
